Manhole Inspection Summary

Manhole # S29II_005MH

Location Address: **1601 MCMECHEN ST**

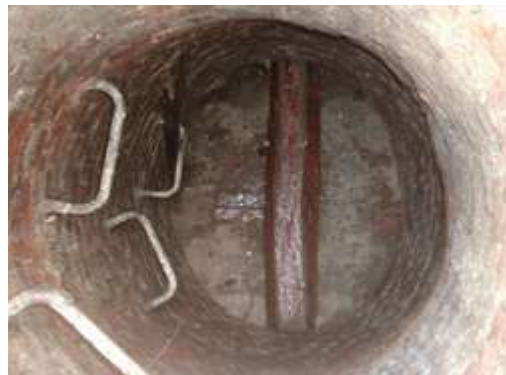
Top View

Bench ☒ Exists Material: **Brick** ☐ Parged ☒ **Debris** (not Condition related)

Steps Count: **4** Missing: **0** ☒ **Corroded**

Surcharge ☒ **Evidence Of Surcharge** Depth: **2** (ft.) ☐ Active Surcharge Present

Evidence of surcharge - Bench debris.
Corroded steps.

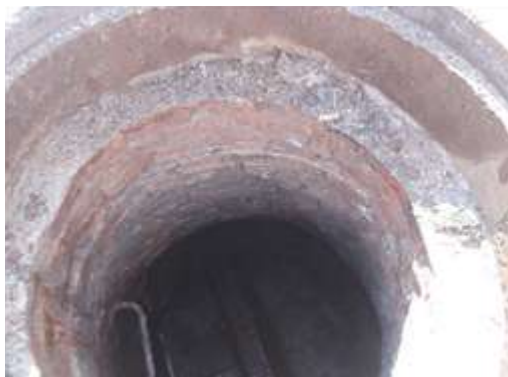
Defect

Frame Offset: **4** (in.) Condition: ☐ Sound ☐ Cracked ☒ **Leaks**

Condition: ☐ Sound ☐ Cracked ☐ Root Intrusion ☐ Loose Brick ☒ **Deteriorated**

Infiltration: ☐ None ☒ **Joint** ☐ Cracks ☒ **Mortar** ☐ Roots ☐ Wall

Infiltration: ☐ None ☐ Joint ☐ Cracks ☒ **Mortar** ☐ Roots ☒ **Wall**

Frame leaks. Frame offset. Adjustment deterioration and infiltration. Corbel infiltration - other side.

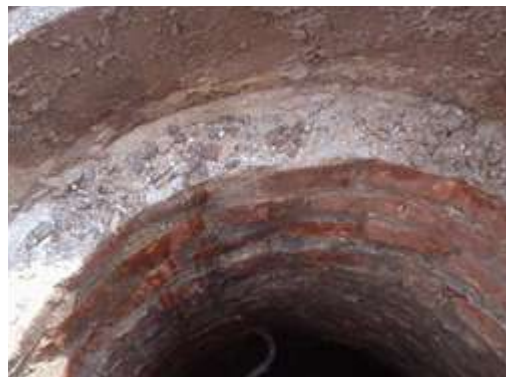
Defect

Frame leaks. Frame offset. Adjustment deterioration and infiltration. Corbel infiltration.

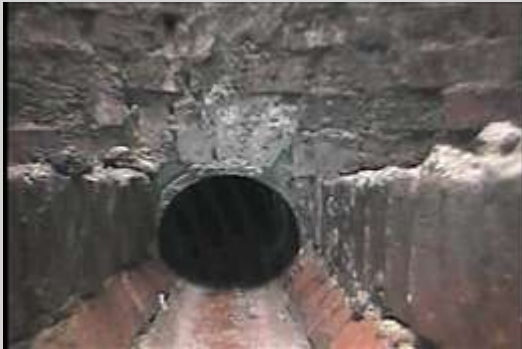
8 in. Circular Gravity Sewer Pipe Out @ 12 O'Clock

Condition: ☐ Sound ☐ Cracked ☐ Root Intrusion ☒ **Deteriorated** ☐ Leaks ☐ Debris

Channel deterioration.

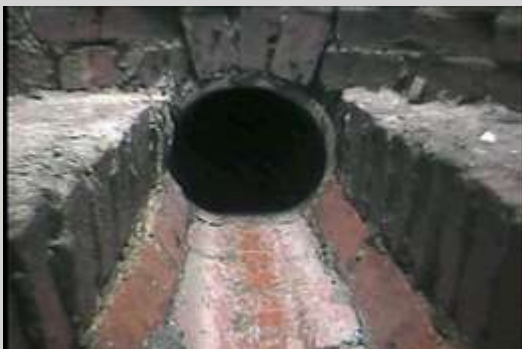
8 in. Circular Gravity Sewer Pipe In @ 6 O'Clock

Infiltration: **Evidence** Pipe Seal Cond: **Unknown**
